## Application of 64-slice spiral computed tomography angiography in extremity vascular injuries

Genet. Mol. Res. 14 (1): 170-179 (2015)

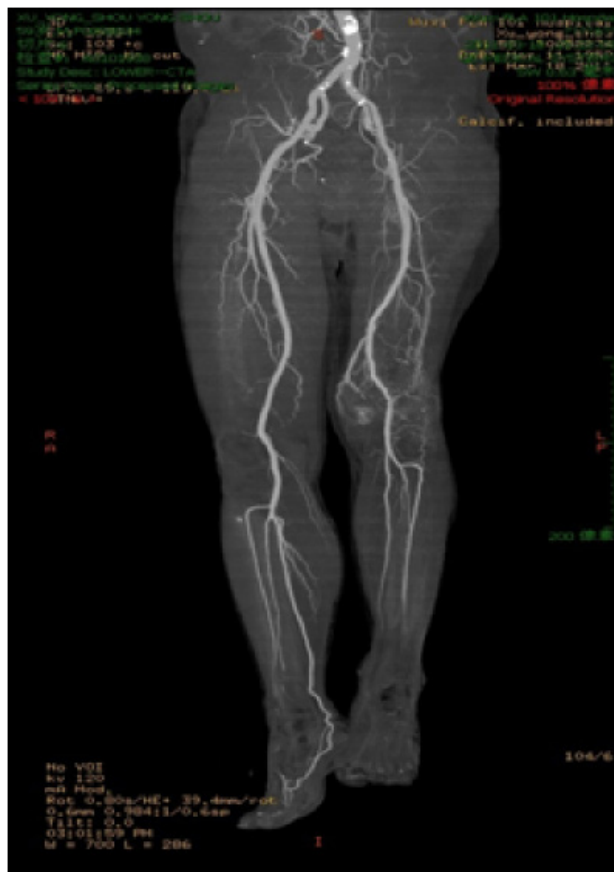
**Figure 1.** Increase, thickening, and tortuosity in the peripheral vascular branch of the hypomere in the left femur. It is possible to see high density image in soft tissue, which represent the Ultravist® oozing shadow.

The direct sign of vascular rupture on CTA is interruption of vascular continuity, and the exudation of irregular floc-like high-density contrast agent (Figure 1), which can penetrate into the adjacent soft tissue or muscle, similar to active bleeding of a limb artery, and may lead to hemorrhagic shock or death. Vascular rupture can also lead to thrombosis and occlusion. CTA reveals that part of artery breaks exhibit filling defect. In this study, two cases of vascular rupture which lead to thrombosis and occlusion were detected by CTA, and confirmed during surgery (Figure 2).

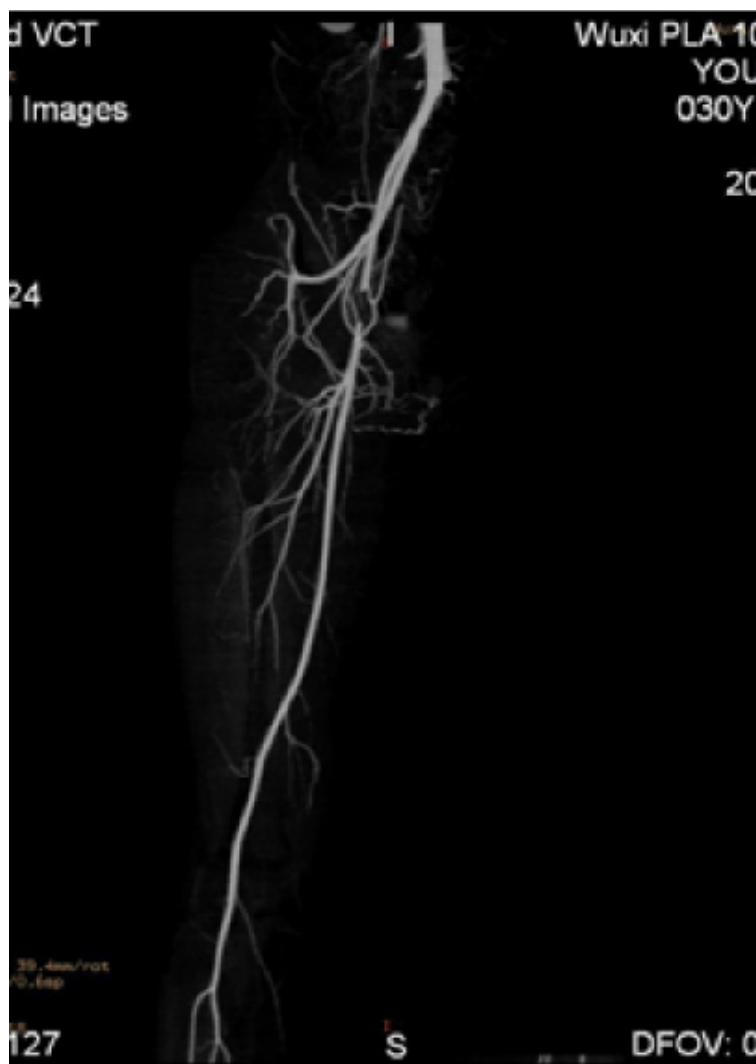
**Figure 2.** In the right side of the iliac artery, there are strips filling the defect shadow, which presents as a vascular occlusion. The range is nearly 2 cm, surrounded by small patches, which represent the Ultravist® oozing shadow.

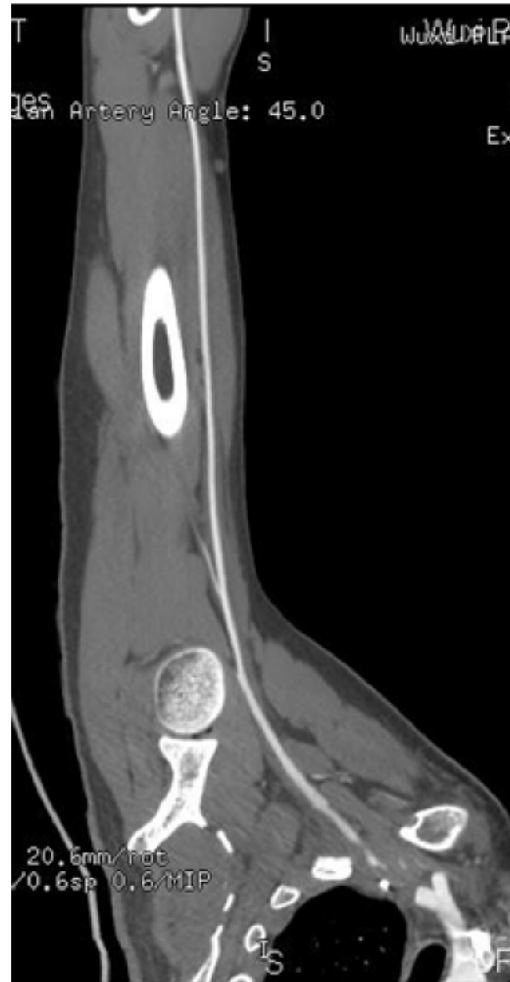
**Figure 3.** We can see the right subclavian artery by curved planar reconstruction. Visible blood vessels of the initial segment of the right subclavian artery (1 cm away from the opening) appeared truncated. The range is about 2 cm, and internal bar-like strips fill the defect shadow. The computer tomography value is about 65 Hu. The diameter of the distal and right axillary artery lumen is unequal, part of which appears as a wavy shape. The range is about 5 cm. There are visible small patches of signal contrast agent leakage in soft tissue, and surrounding soft tissue swelling.

The smooth muscle of the vasculature will forcibly contract for a prolonged period when the vessel wall suffers a blunt trauma. The CTA will show signs of arterial stenosis, and the stricture lumen density will fade. In general, arterial stenosis is considered severe when it is greater than 75% of the artery caliber. Artery spasm is not associated with organic damage to the vascular wall, but a long period of severe spasms can cause vascular thrombosis and occlusion, leading to limb ischemia and even necrosis. There were seven cases of arterial spasm and two cases of occlusion in the current study (Figure 3).

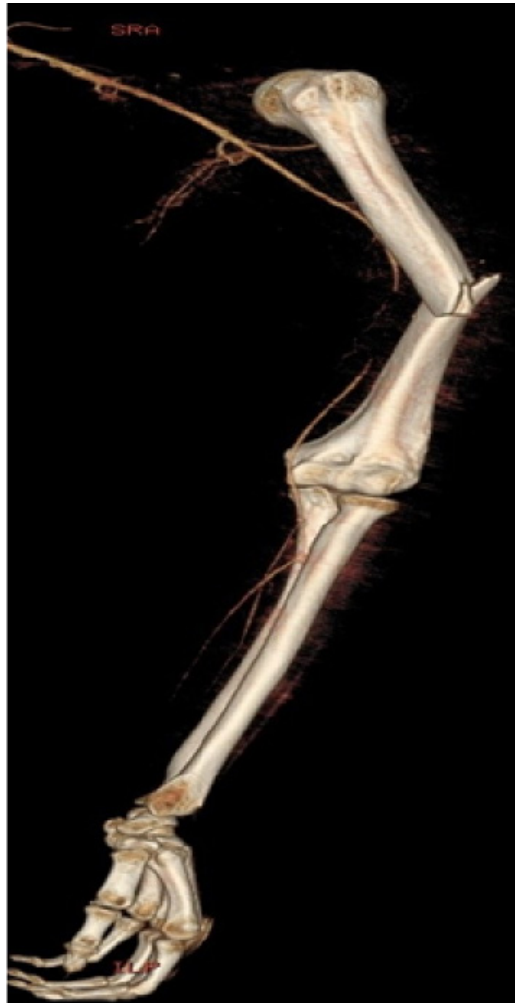
**Figure 4.** The volume rendering icon shows that there is no image in the middle of the left brachial artery and that the distal edge of the injured vasculature is rough. There is a comminuted fracture in the middle of the left humerus. The sides of the broken bone form an angle, and there is no push to the brachial artery.

There was one case involving a pseudoaneurysm in our study. The patient hurt their right foot in a car accident, and clinical examination revealed a beating mass in the right inward heel. An emergency lower limb CTA (Figures 4-5) revealed a round, uniform intensity shadow in the right inside of the calcaneus with a clear edge.

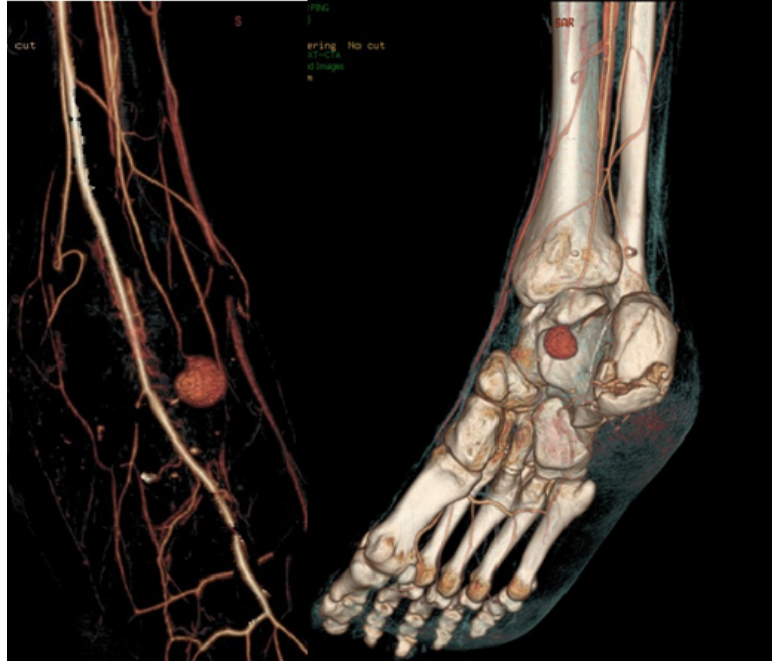
**Figure 5.** It is possible to see round uniform abnormal enhancements in the inside of the soft tissue in the right foot, which appear as a clear realm and connect with the inside arteries in the right foot. The right side of the calcaneal has comminuted fractures. The ends of fractures have counterpoints. The fracture line is clear.

In addition, it was connected to the inside artery of the bottom right foot with a comminuted fracture in the right calcaneus. According to the CTA details, there was a pseudoaneurysm in the right inside of the calcaneus. The mechanism behind pseudoaneurysm formation is that the arterial fracture causes the development of a hematoma, the outer layer of which is formed by organizing fibrous tissue. The artery break is still connected with the hematoma cavity. There are no normal vessel wall structures in pseudoaneurysms, and they may rupture at any time. At the same time, pseudoaneurysms may compress adjacent organs such as nerves and bone, and cause additional damage. The intra-capsular blood clots are also a potential source of emboli. Furthermore, fever in the adjacent skin, as well as pain with weak pulsation, may be misdiagnosed as abscesses and be incised, which will cause serious consequences. As a result, the CTA can determine the pseudoaneurysm location in a timely manner, as well as the extent and relationship with adjacent structures, and provide a reliable basis for clinical treatment.

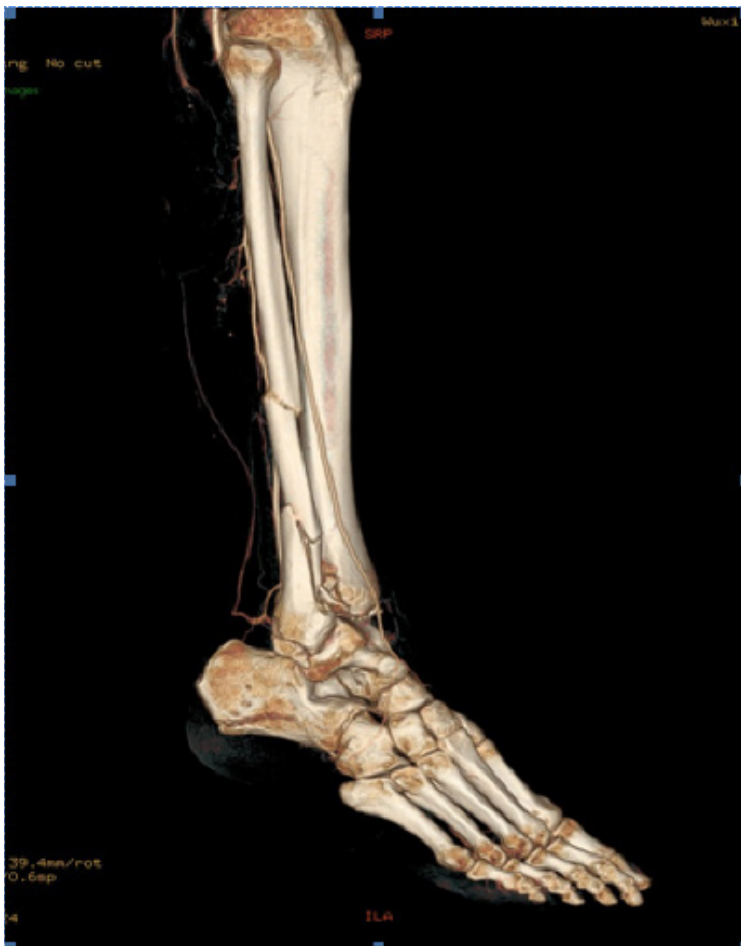
**Figure 6.** There is a comminuted fracture on the left side of the lower segment in the tibia and fibula. The capitulum of broken bones appears as a slight dislocation. The posterior tibial artery connects to the vein.

If damage to the adjacent artery and vein occurs at the same time, blood from the artery and vein will mix, and cause the development of a traumatic arteriovenous fistula, due to the pressure gradient between the artery and vein, which may cause a weakened pulse or insufficient blood supply to distal limbs. However, a traumatic arteriovenous fistula can be easily detected using CTA (Figure 6).
